## Albany Wind Farm Rehabilitation and Landscape Management Plan

Western Power Corporation  
Landscape Management Plan

March 2001

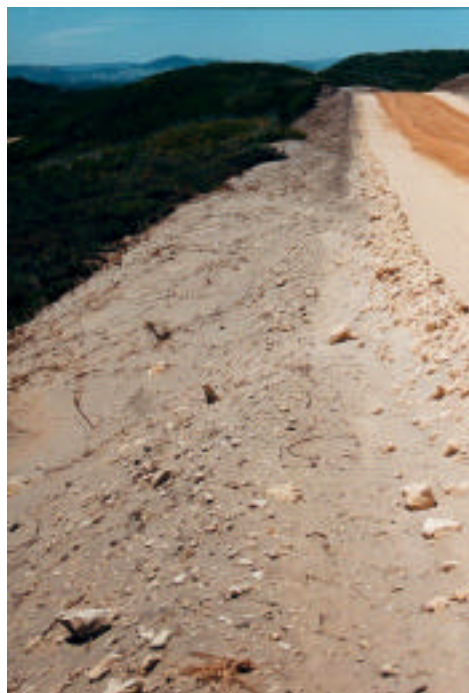
Currently, all cut and fill batters have been spread with topsoil and mulched vegetation material where this was available. In some areas however, there has been a shortfall of material and batters are not adequately covered (see Plate 1; Figure 1). These will require some additional treatment both to stabilise the surface and to ensure that rehabilitation takes place in a reasonable timeframe.

**Plate 1: Exposed batter at Chainage 1628**

Additional mulch or brushing material will need to be sourced to cover these slopes. To minimise the risk of weed introduction to the area, this should ideally be sourced from within the reserve. If other areas within the reserve require clearing then any excess mulched material from these locations could be transported for use on these batters. Any other excess mulch material that is currently not being utilised on site could also be relocated and used on these batters.

Should these approaches not prove feasible, then mulch could be sourced externally and brought into site from a location approved by the City of Albany and CALM. If this approach is adopted, then weed hygiene will need to form an important consideration to ensure that novel weed introductions do not arise.

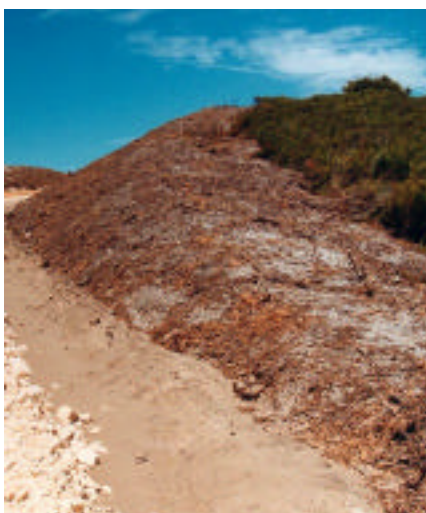
There are a small number of locations on site where construction of the access roads has required substantial areas of cut and fill. These include batters at Chainages 1254, 1375 and 1944 (see Figure 1). At present most of these have been well mulched and this appears to have stabilised the surface adequately for the short term (see Plate 2). However, some of the larger batters only have a sparse coverage and this may not prove adequate for surface stabilisation or revegetation in an acceptable timeframe (see Plate 3).

**Plate 2: Well mulched batter at Chainage 1375**

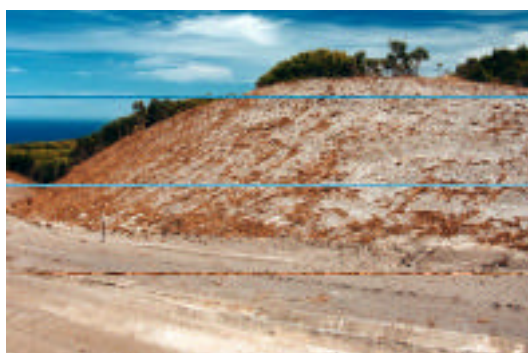
**Plate 3: Partially exposed batter at Chainage 2000**

The suggested approach is to fully mulch areas where major batters are lacking adequate coverage and to monitor their progress in respect of stability and revegetation progress (see Section 4.0).

Winter storms and heavy rains may mobilise surface material or generate significant erosion on these large exposed surfaces. If this occurs, then the surface will need to be physically stabilised, seeded and possibly also planted with tubestock of selected locally occurring species. This would consist of hand broadcasting a bulked seed mix on to the batters comprising a selection of low species with spreading, sand-binding root systems (see Section 3.0; Appendix 1). Brushing using locally occurring tree and shrub species could then be applied to provide sand stabilisation and wind protection for establishing seed. Peppermint *Agonis flexuosa* would probably provide the most appropriate source of brush material. Brushing should be laid vertically on the slope to provide uniform cover and then secured by means of wire strands attached to stakes every few metres.

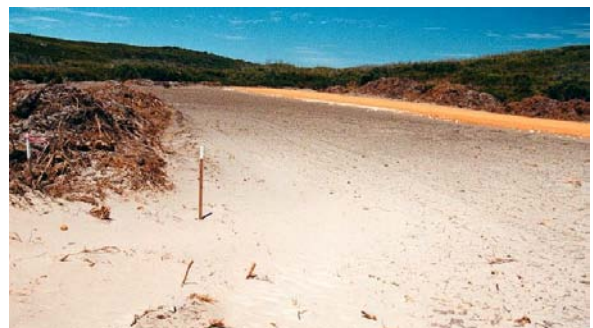
All turbine areas currently have stockpiled topsoil and mulched vegetation material stored adjacent to the work area (see Plate 4). On completion of the construction work, the disturbance area for the turbine pad will be substantially reduced. The stored material will be respread and the reclaimed areas deep-ripped to a minimum depth of 400 mm. For most turbines, there is likely to be some shortfall in material to provide adequate coverage of mulch and/or topsoil.

**Plate 4: Turbine pad showing stockpiled topsoil and mulch**

In these areas, additional mulch could be sourced as outlined in Section 2.3 for minor shortfalls. If there is substantial area requiring additional treatment, then this should be managed via the techniques outline for the reclaimed road margins in Section 2.5.

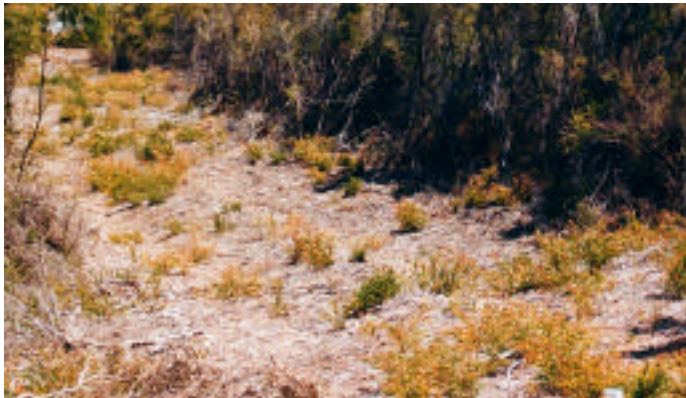
Most slashed areas within the site are old alignments of access tracks that were subsequently modified on consideration of grade and other issues. These areas are already beginning to show significant epicormic regrowth (see Plate 5) and no additional treatment is likely to be required. Access points to these tracks from the main access network will need to be permanently closed off with large boulders where this has not already been done.

**Plate 5:**  
**Revegetation under way on**  
**slashed track alignment in the**  
**vicinity of turbine number 12**

These sites will be included in the ongoing monitoring programme which will identify the need for additional remedial action if any (see Section 4.0).
